Manhole Inspection Summary

Manhole # S19II_037MH

Location Address: **1826 PAYSON ST**

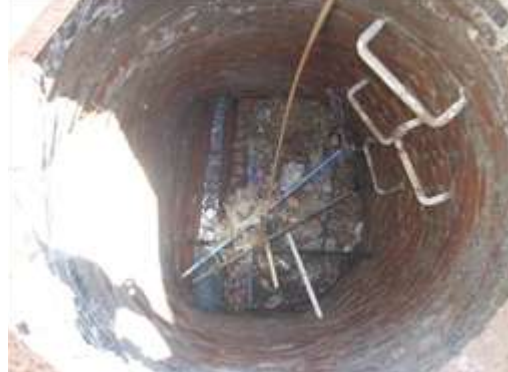
Top View

Condition: ☐ Sound ☐ Cracked ☐ Root Intrusion ☐ Deteriorated ☐ Leaks ☒ **Debris**

Steps Count: **5** Missing: **0** ☒ **Corroded**

DEBRIS ON BENCH AND CORRODED STEPS

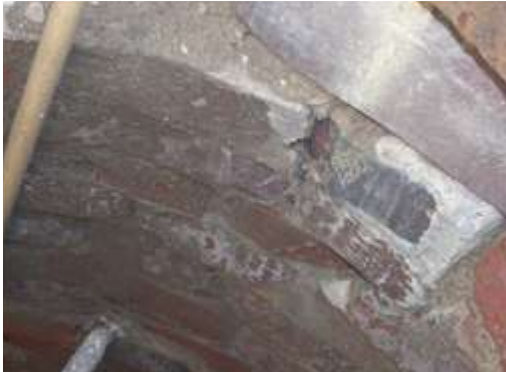
Defect 2

Condition: ☐ Sound ☐ Cracked ☐ Root Intrusion ☐ Loose Brick ☒ **Deteriorated**

CORBEL DETERIORATION

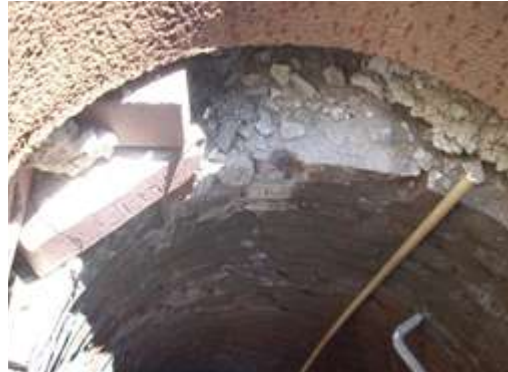
Defect 1

Condition: ☐ Sound ☐ Cracked ☐ Root Intrusion ☐ Loose Brick ☒ **Deteriorated**

MAJOR CHIMNEY DETERIORATION

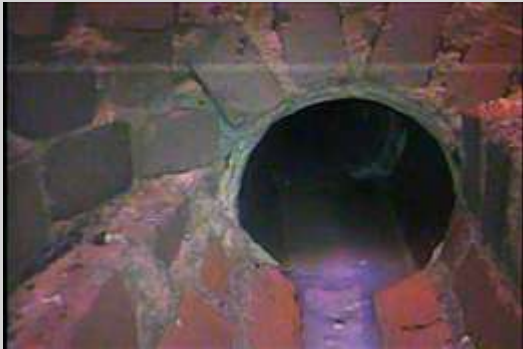
12 O'Clock Outflow

Pipe Height: **8.4** (in.) Rod and Bar (Angled)
Pipe Material: **Clay** ☐ Pipe Lined
Invert Depth: **10.92** (ft.) Flow Characteristics: **Slow**
Deposits: ☒ None ☐ Mud ☐ Sludge ☐ Debris ☐ Grease
Silt Depth: (in.) Deposits Extent:
Infiltration: **None** Pipe Seal Cond: **Sound**

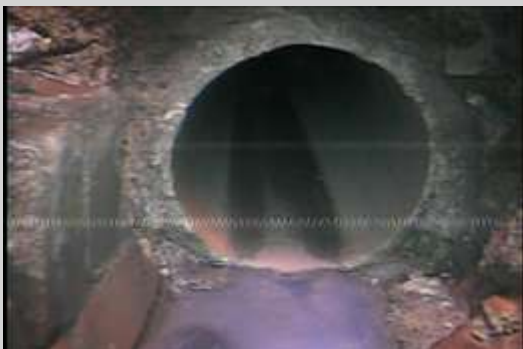
6 O'Clock Inflow

Pipe Height: **7.2** (in.) Rod and Bar (Angled)
Pipe Material: **Clay** ☐ Pipe Lined
Invert Depth: **10.88** (ft.) Flow Characteristics: **Slow**
Deposits: ☒ None ☐ Mud ☐ Sludge ☐ Debris ☐ Grease
Silt Depth: (in.) Deposits Extent:
Infiltration: **None** Pipe Seal Cond: **Sound**
